National Public Health Laboratory (NPHL) Block B

Refurbishment project and associated works

National Public Health Reference Laboratory, Nairobi,
Kenya.

User Requirement Specification

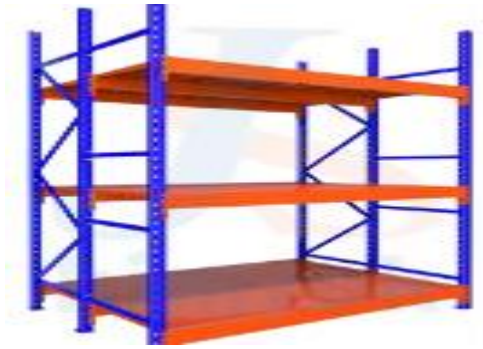
Procure and Install racks (specifications provided in the relevant section).The racks should be of stainless steel, rust-proof, low temperature resistant, wear resistant and corrosion resistant as well as adjustable to customized sizes.

Sample of the storing racks:
